**Archimedean Screw
Hydropower installation at
Linton Lock**

HERITAGE STATEMENT

Mann Power Consulting Ltd.

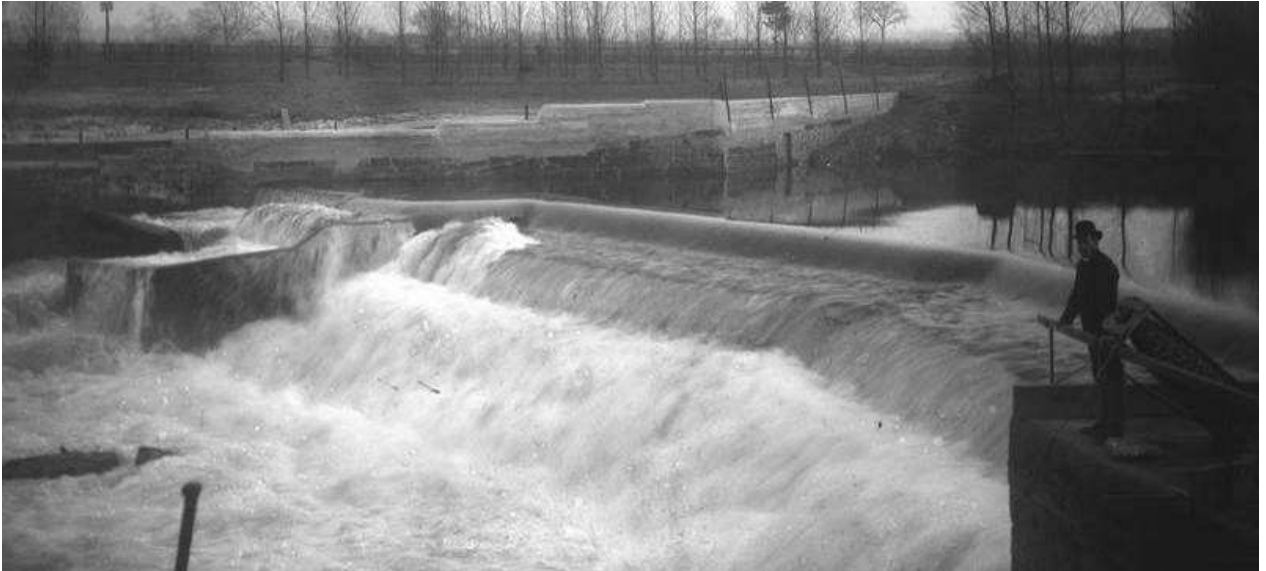
The top photo (undated) shows the weir and fish pass in the 1880s-90s in high flow conditions.²³

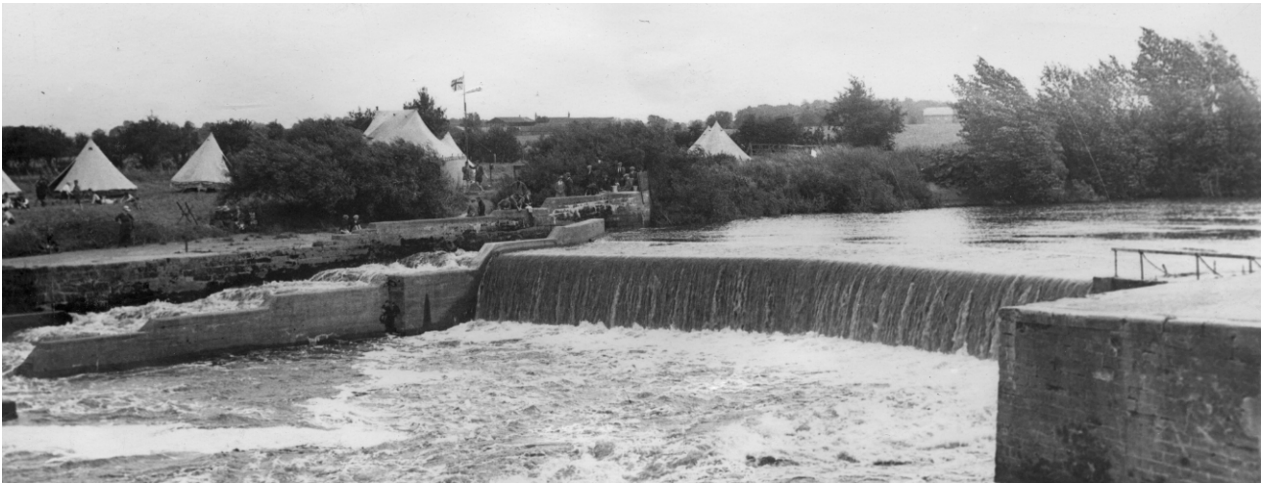
The centre photo shows the weir and fish pass in moderate to high flow conditions when the hydro scheme was formally opened on 1st August 1923.²⁴ It is clear that:

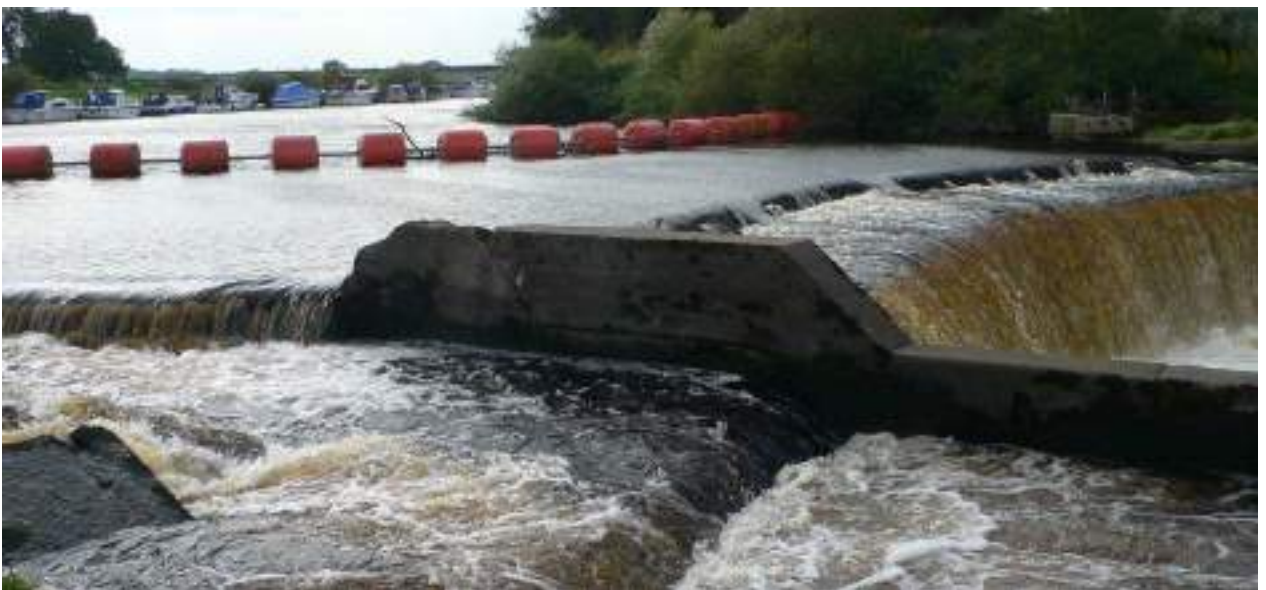
The lower photo shows the current state of the fish pass. Its high upper wall has been broken away. The shutters have been removed from the weir edge, and boards reinstated set back from the edge.

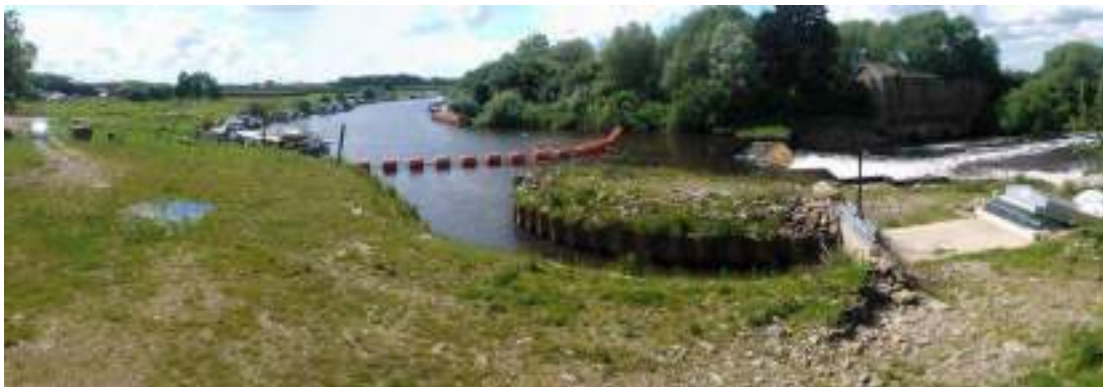
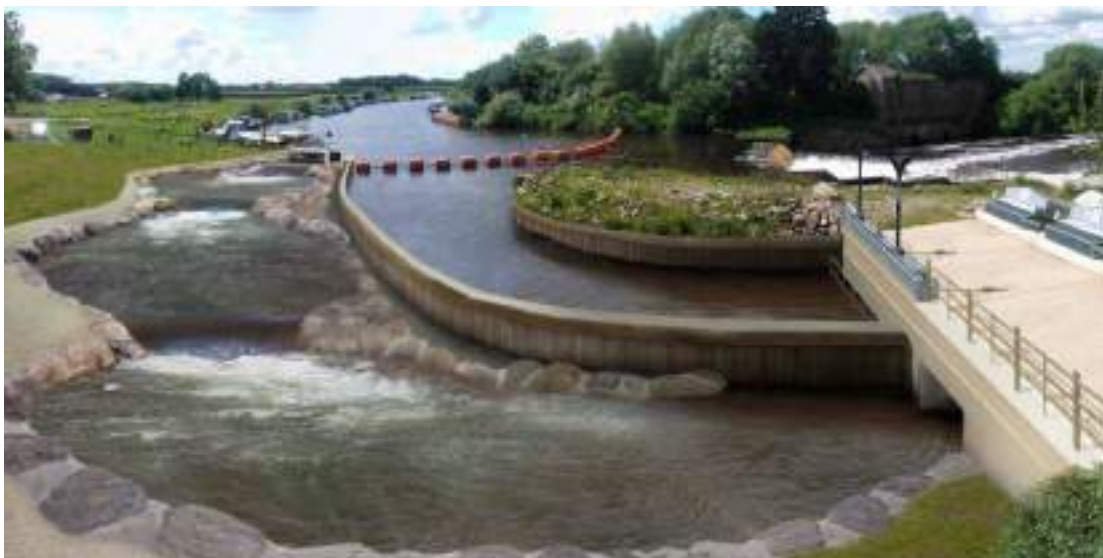
Please refer to design drawings. In addition, the images below show before and as-proposed views of the upstream panorama, giving an indication of the intended visual form and finish of the altered intake channel and new fishway.

It is proposed to install an additional Archimedean screw generating system in a new channel bypassing the weir, adjacent and east of the existing system, together with a nature-like fishway (of pools and glides) adjacent further to the east. A lifting bridge is proposed for access across the new channel. At its upper end, the new turbine would have a flood-proof concrete enclosure around the generator. It is proposed that this enclosure is crowned by a railed viewing deck, with the wall finishes designed to replicate the superstructure of a boat giving it a sense of place in a navigation setting alongside the River Ouse.

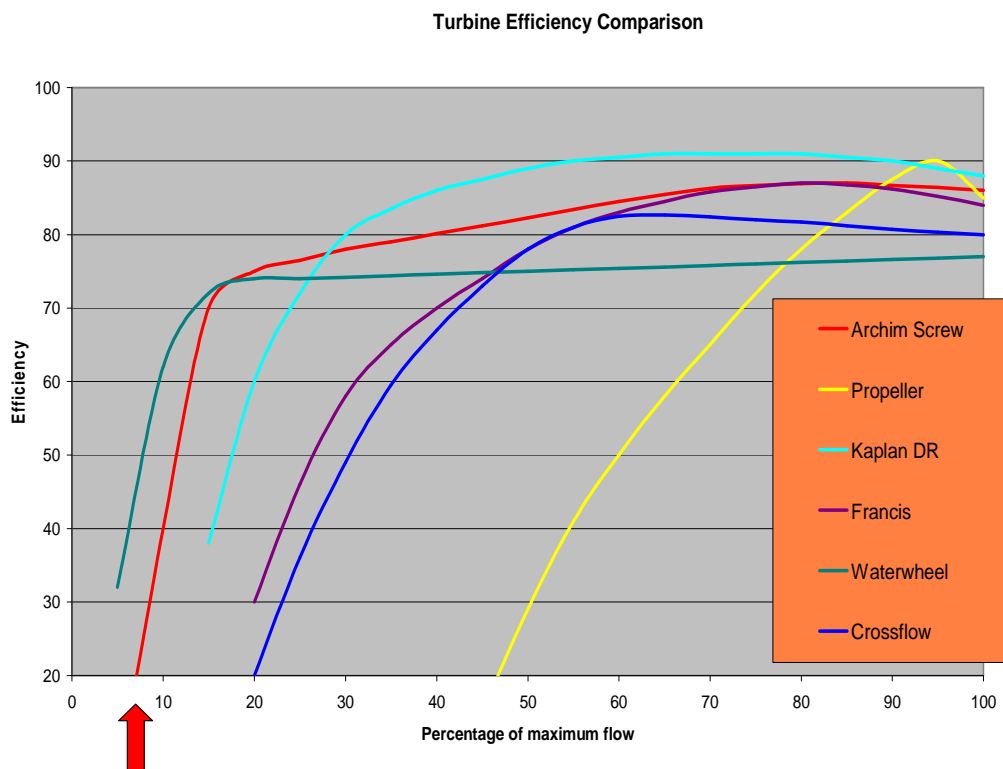
When estimating the energy delivered over the course of the year, it is most important to consider the effect of changing head and flow on efficiency. Favourable performance of the screw in this respect is reflected in the energy capture calculations provided to the client.

close to the gross head at the site. In addition, full flow capacity is maintained through the screw even when the gross head is reduced during times of high water. These factors can all have a significant impact on the actual annual generation possible from a particular site. A thorough assessment of the actual performance of an operating system was carried out by independent consultants Nick Bard Hydro Systems, which proved that the performance matched that predicted by the manufacturer.²⁶
